GIB SYLVANIA

STEREO HI-FI

SUPPLEMENT 4 TO BULLETIN: R75-3

This supplement lists all code changes to date on the R75-3,-4 chassis.

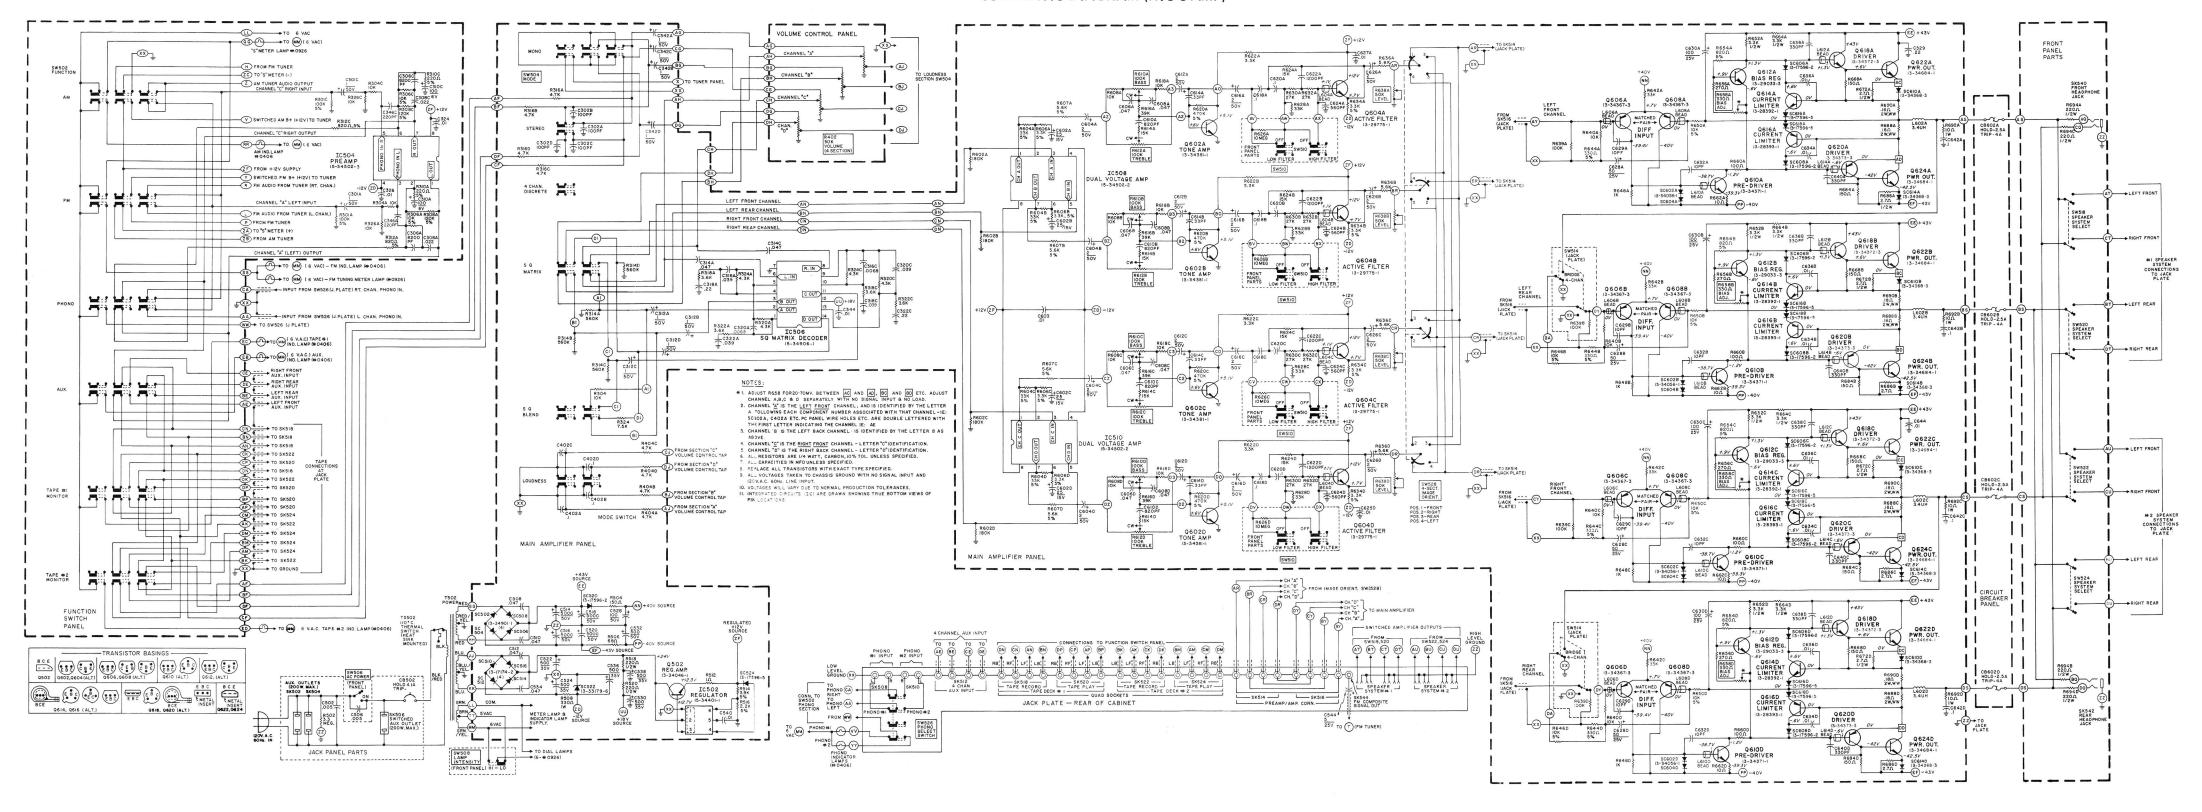
SCHEMATIC DIAGRAM (R75-3 AMP) -----

CODE	CHASSIS	PANEL CODE	DESCRIPTION OF CHANGE
00	ALL	_	INITIAL PRODUCTION.
01	-3	_	POWER AMPLIFIER OSCILLATION.
			1) 33pF, N150 capacitors added from Base to Collector of Q606A,B,C,D on foil side of P/C panel.
01	-4	_	MULTIPLEX SEPARATION DEGRADES WITH TEMPERATURE CHANGE.

1) BLUE/WHITE, RED/WHITE, BLUE and RED leads reversed on headphone jacks.
			The industry standard is for LEFT channel audio to the TIP of the headphone plug, and RIGHT channel audio to the RING of the plug.

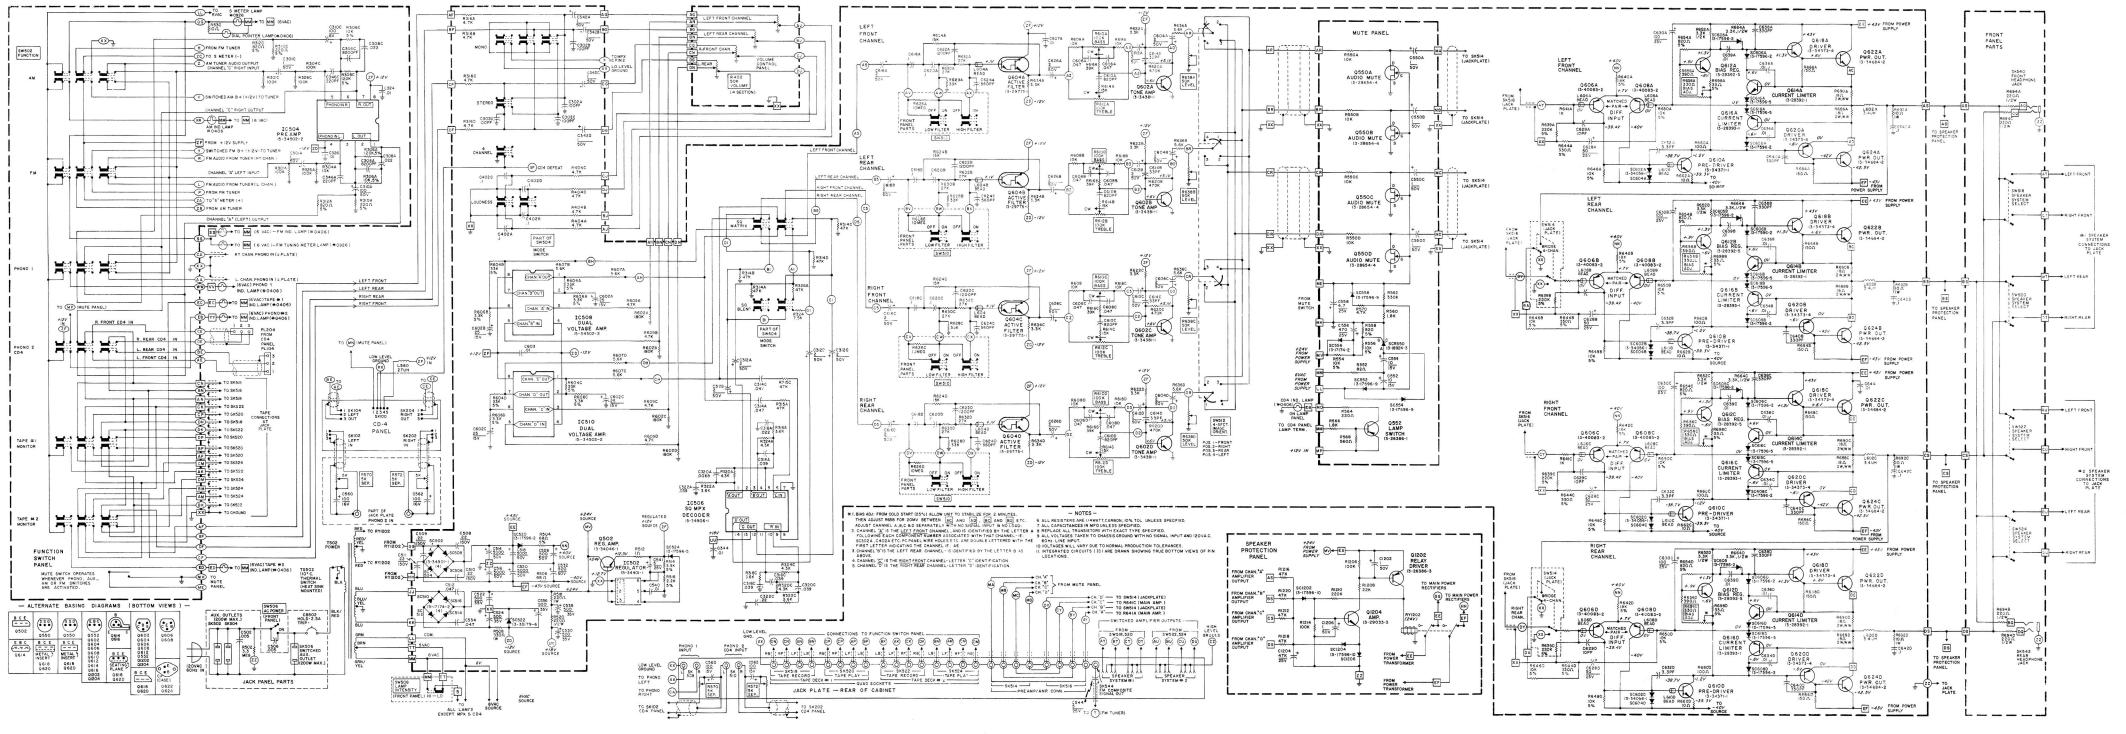
- SCHEMATIC DIAGRAM (R75-4 AMP) -----

1) Cores replaced in T4 and T6.
02	-3	_	CHASSIS IDENTIFICATION ONLY.
			To provide a means to identify finished goods built with SQ chips with date codes of 7331 and 7332.
02	-4	A	IMPROVED SPEAKER PROTECTION.
			 CB602 replaced by 02-36800-1 relay panel. C629 removed. R640 removed. C632 value changed to 3.3pF. R639 value changed to 220K. R648 value changed to 10K.
02	-4	В	RELAY TRIPS WHEN TUNING ACROSS FM BAND. (02-36800-1 PANEL REVISION).

1) C1204 value changed to 100MFD/15V - new part number is 41-32477-37. NOTE: All CODE A relay panels with this change prior to CODE B are identified by a RED STRIPE through the identification sticker.
03	-3	-	TO COMPLY WITH IHF AND INDUSTRY STANDARDS.
