REPAIR Audio Amp

Notes From The Field

SERVICE NOTES.

THE SYLVANIA SERVICE NOTEBOOK is published monthly by the Service Department of the Entertainment Products Group at 700 Ellicott Street, Batavia, New York. It is available to current subscribers for Sylvania Service Literature. Information contained herein is presented as an aid in

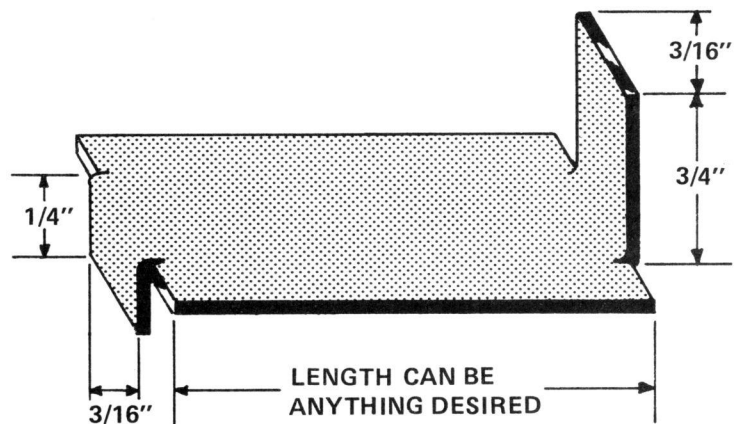
IC PULLER OUT OF SCRAP METAL

The short end is used when there is insufficient clearance for the long end. Just slide either end under the chip and lift.

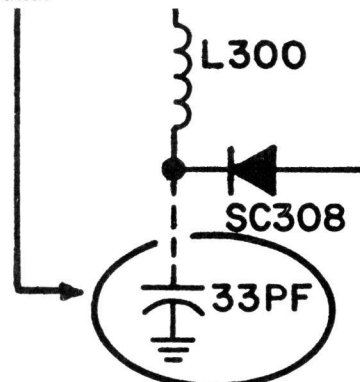
D19 CHASSIS. THE SET WILL RADIATE A NARROW VERTICAL BAND OF INTERFERENCE STARTING FROM THE LEFT SIDE OF THE CRT (FACING SET) TO THE RIGHT SIDE. (ON STRONG TO MEDIUM SIGNALS.)
Q308 Radiation.

1. Change Q308.
2. Add 10PF capacitor from base to ground of Q308.
3. Add ferrite bead (22-28072-2) on the base and emitter leads of Q308.
4. Add 33PF capacitor between junction of L300 and SC308 and ground.
