GTE SYLVANIA

STEREO HI-FI
SUPPLEMENT 1 TO
BULLETIN R53-3,-4,-7,-8

MODEL: MS3722

CODE CHANGES
R53-3,-4,-7,-8

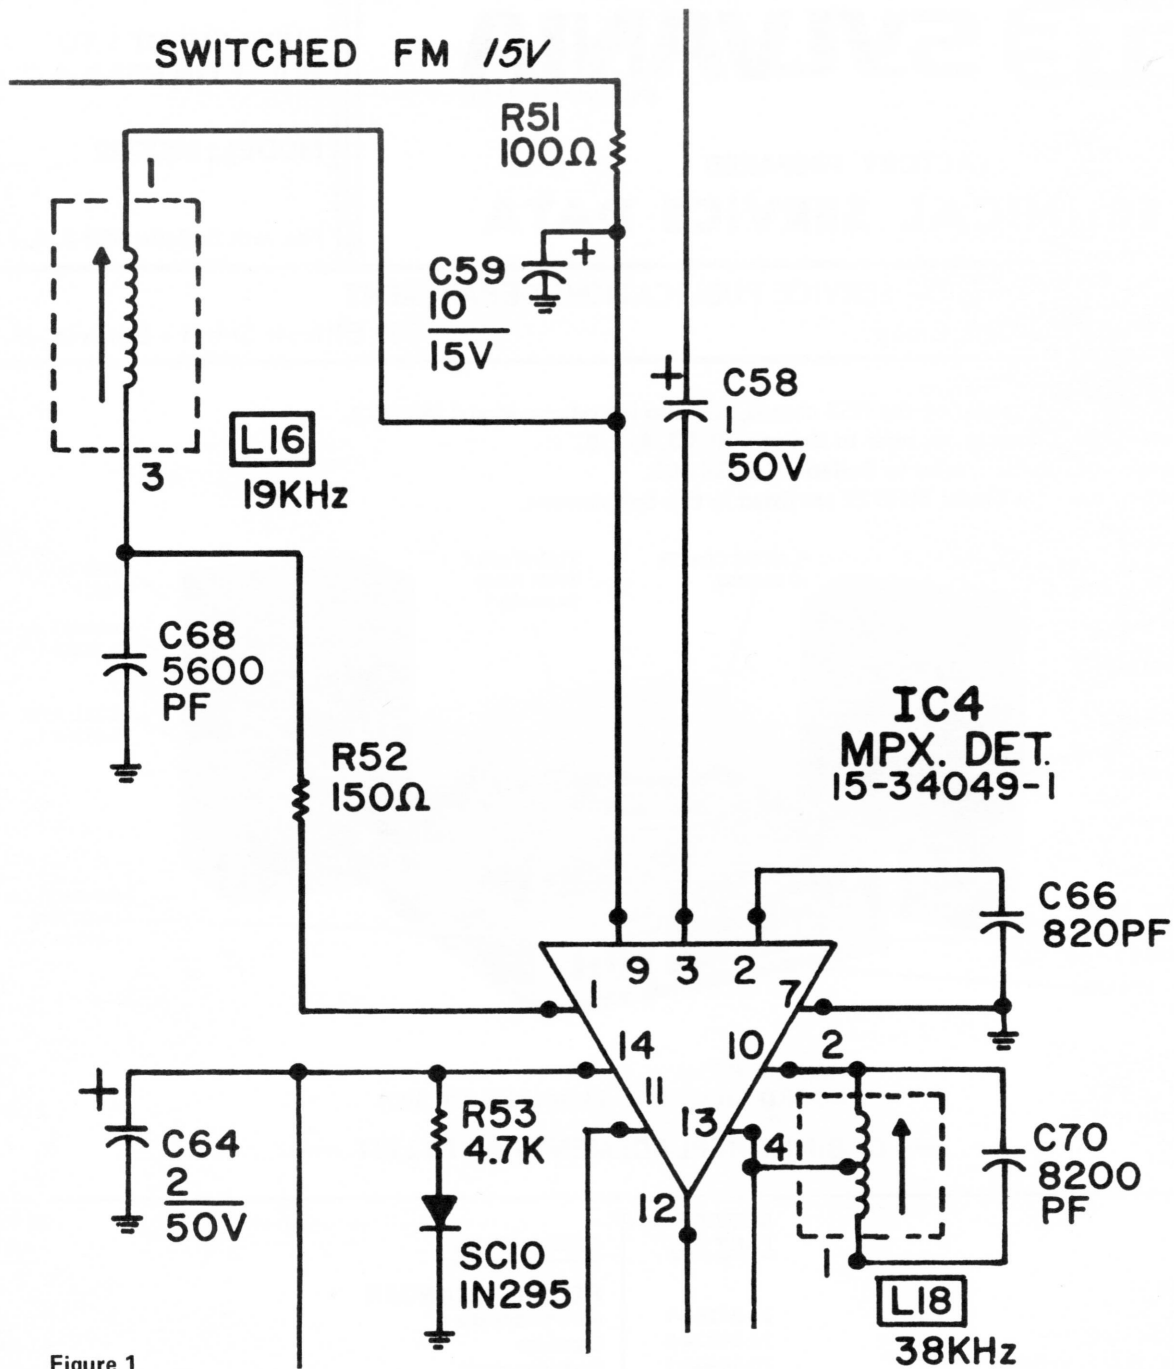
Figure 1

CODE 05:

REASON: Stereo operation becomes inoperative when tuning into signal.

DESCRIPTION: The following changes were made:

1. 19kHz coil (L16), pin 1, connected directly to pin 9, IC4.
2. R51 (100 ohm) resistor added.
3. C59 (10MFD/15V Electrolytic) added.
4. R52 changed from 1K variable to 150 ohm fixed resistor.

SEE FIGURE 1
