SHORTED TURN CHECKER

by Bill Reed, Toledo Appliance, Inc., Toledo, Ohio.

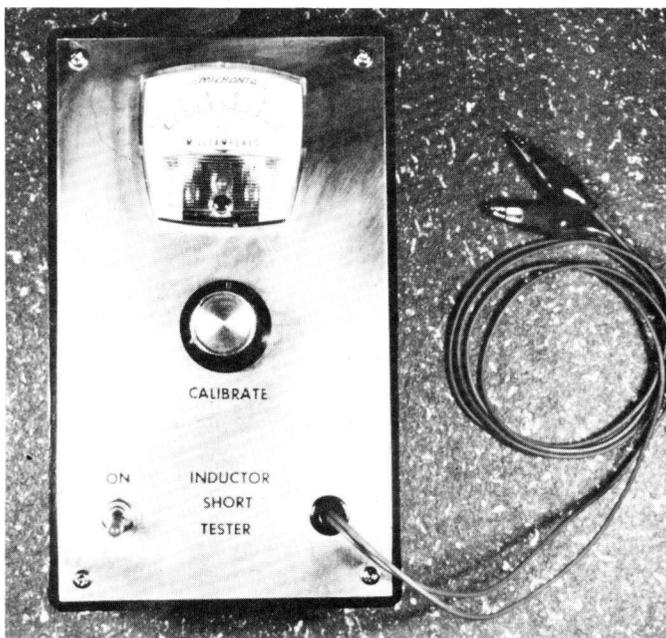
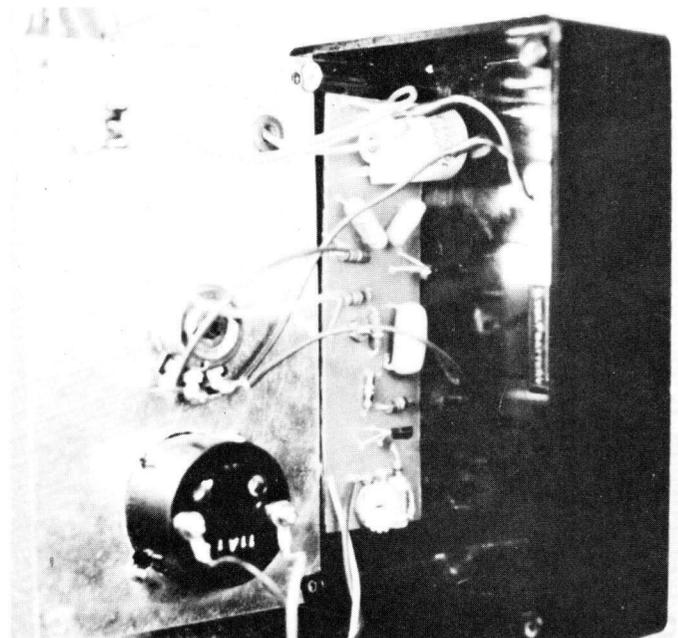
After running into problems with various shorted turn checkers that don't work very well with modern, low impedance, yokes and transformers, I decided to construct one that would give accurate results with coils of high or low impedance and that would be easy to use and read.

Construction details will vary, but I used a small plastic box, and etched a P. C. panel. For construction of a single unit, wiring on a "perf-board" will be quite adequate.

After construction, the unit should be adjusted as follows:

1. Set slug in oscillator coil, flush with outside end of coil (top).
2. Adjust bias pot (R2) for approximately 400 ohms.
3. Rotate "Calibrate" control full CCW.
4. Apply +9 volts to unit.

5. The meter should read approximately .1ma. If reading is higher, (.4ma or above), back-out oscillator coil slug until meter drops below .2ma.
6. Slowly advance "Calibrate" control CW. At some point the meter will jump to .4 or .5ma.
7. Continue to advance "Calibrate" control to full CW.
8. Adjust bias pot (R2) for .8 to 1ma reading.
9. Rotate "Calibrate" control to full CCW. The meter should now read .2ma or below.
10. Oscillator slug adjustment is correct when meter jumps to .4 or .5ma at approximately 1/3 rotation of the "Calibrate" control. Do not adjust slug for maximum reading.

1. Turn on and slowly advance "Calibrate" control until meter jumps to .4 or .5ma with test leads open.

2. Connect test leads to coil to be tested. If meter reads the same or goes up scale, the coil is O.K. If the meter drops, there is one or more shorted turn.

M-1 Micronta 0-1ma. or equivalent.

L-1 Horiz. osc. coil, Sylvania part no. 50-27910-1.

Q-1 2N3391A - 13-18365-1

Q-2 2N3694 - 13-29033-3 or -4.
