SOLVING TUNING PROBLEMS IN THE E04 CHASSIS

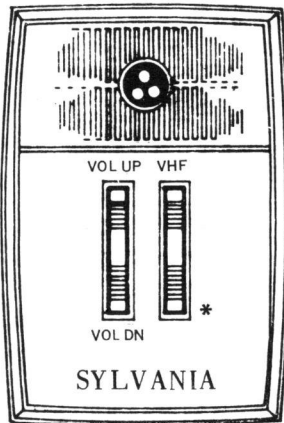
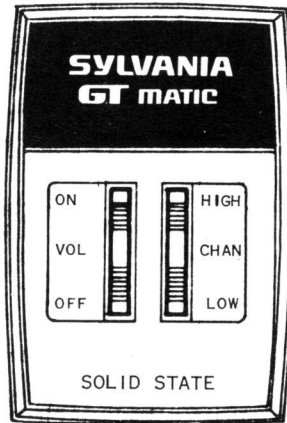
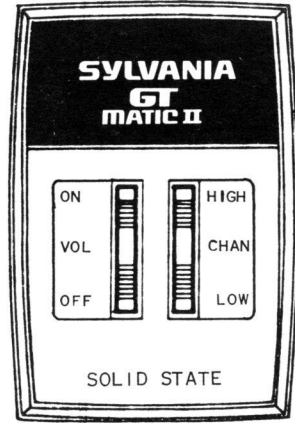
TRANSMITTERS

RC13
 **RC14
 D16-16
 **D16-11
 D19-6

RC15
 E04-2

RC16
 E11-4

**	RC9	RC10	RC11	RC13	RC14	RC15	RC16
B	E01-10-20		D16-6 D19-3-4 D18-3	D16-16 D19-6	D16-11	E04-2	E11-4
5	38.75	USED AS SERVICE REPLACEMENT FOR RC1, RC4.	37.25 35.75	37.25 35.75	37.25 35.75	38.75 35.75	38.75 35.75
5	37.25						
5	41.75						
5	34.25						
5	43.25						
5	40.25		40.25	40.25	40.25	40.25 41.75	40.25 41.75
5	44.75						
5	35.75						
VOLT	1.5 VOLT		1.5 VOLT	1.5 VOLT	14.75 1.5 VOLT	1.5 VOLT	1.5 VOLT
785-1	X 13-23785-1		X 13-23785-1	X 13-35792-1	X 13-35792-1	X 13-35792-1	X 13-35792-1
